# Nelson Lagoon Hazard Impact Assessment

Aleutians East Borough  
3380 C Street, Suite 205  
Anchorage, AK 99503

HDR Alaska, Inc.  
with  
Shannon & Wilson

October 2011

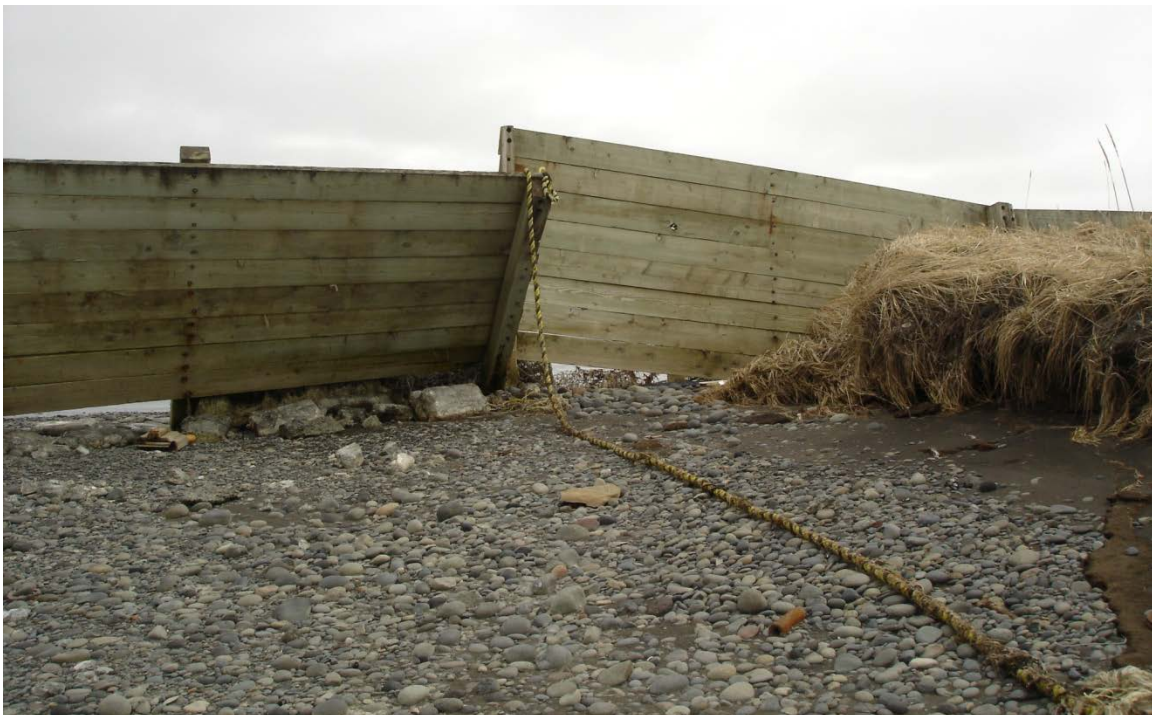
**Figure 18. Damage to Wooden Seawall**

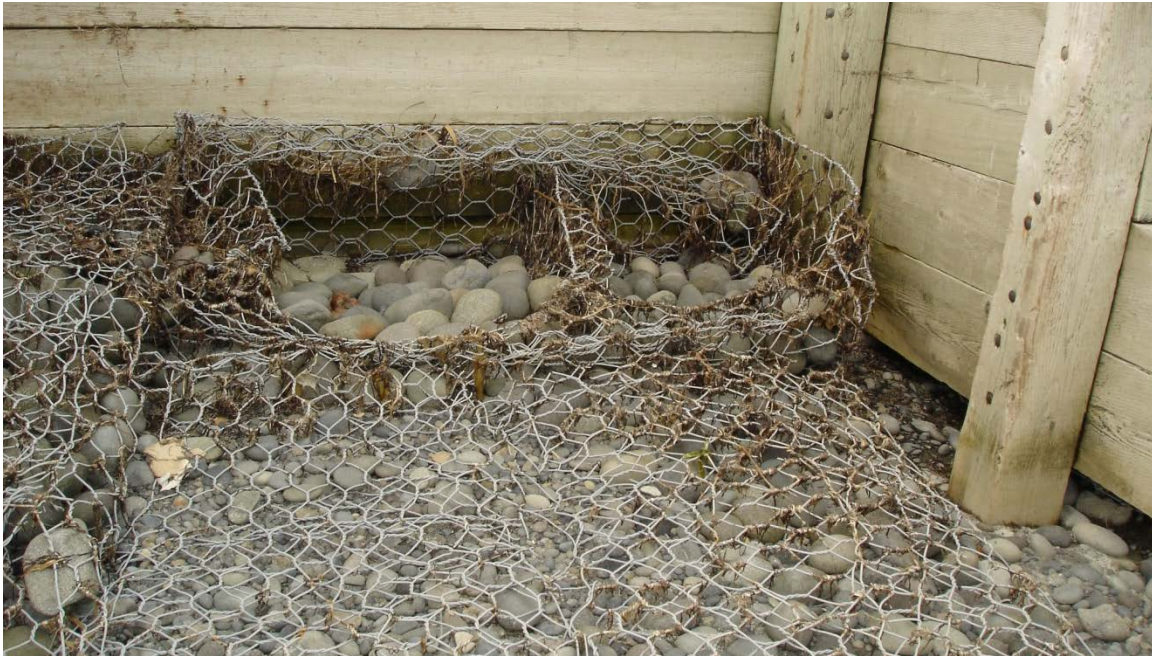
In 1986, gabions (wire mesh cages containing rocks that are used to absorb some of the wave energy) were added to anchor the existing wood seawall (Figure 21 and Figure 22). This project cost approximately \$60,000 and is reported to have had little success because of tides and high winds (USACE 2007). According to AEB, the rocks were undersized compared to the gabion mesh, resulting in the rocks eventually being washed away (U.S. Senate 2004).

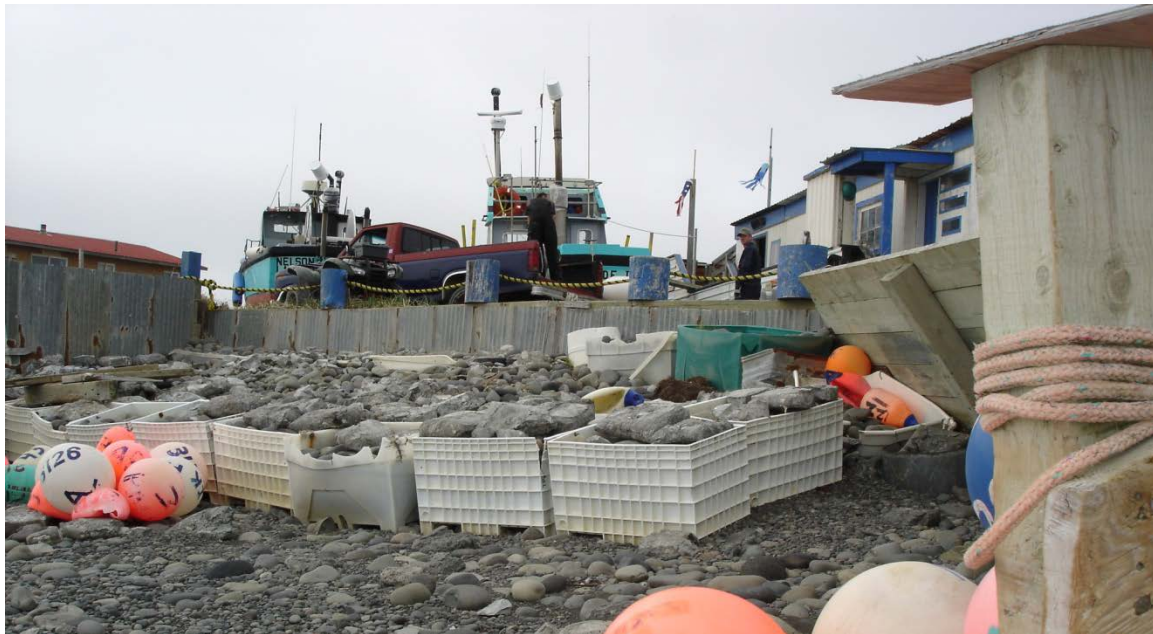
Residents have attempted to utilize available materials to help stabilize the wall and protect it from erosion, including nets, plastic totes filled with cobbles and chunks of concrete, engine blocks, and metal debris. One homeowner has used rock-filled fish totes to help reinforce the wooden seawall and protect his property from further erosion (Figure 23).

**Figure 23. Rock-Filled Fish Totes Used to Reinforce the Wooden Seawall**

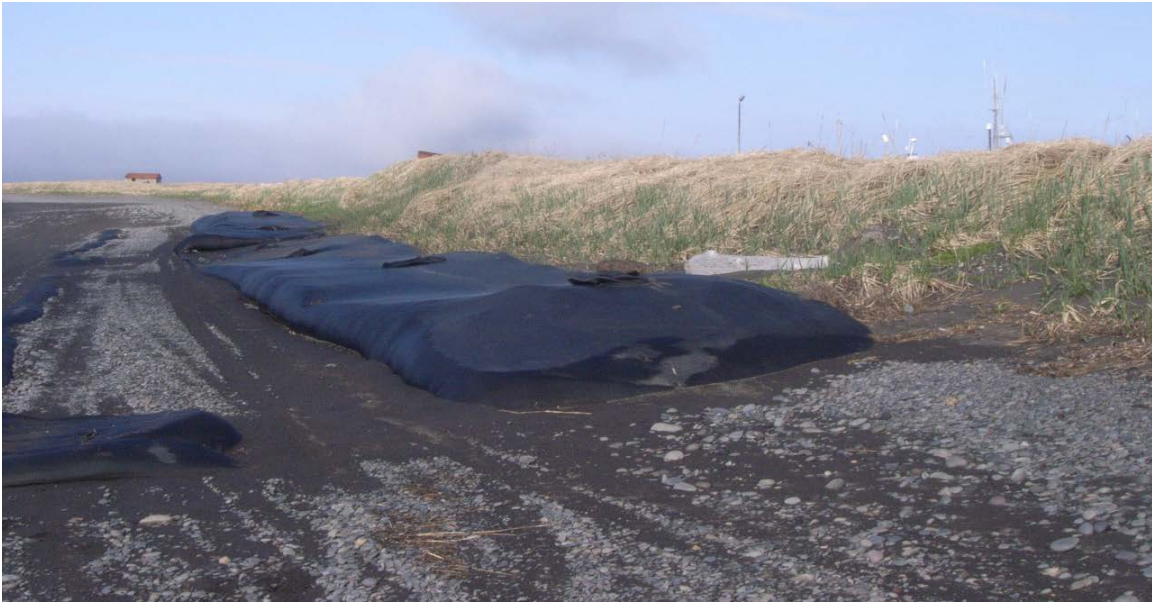
In September 2005, a geotube containment structure, consisting of a sediment-filled sleeve of geotextile fabric, was installed near the city dock (Figure 24). According to the USACE (2007), the finished structure consists of approximately 300 linear feet of geotube that is five feet high with a 7.5 foot scour apron. The USACE reported that when they prepared their document, there had not been enough time to assess the structure's effectiveness. Based on a visual inspection during the May 2011 community visit, the tubes were observed to be in good condition. It was not possible to assess the impact of the geotubes when we made our observations, as we did not have a good basis of initial conditions for the erosion protection and the corresponding control area. However, it did appear that the vegetation extended one to three feet farther in the middle of the tube section relative to the ends, a possible indication the tubes were working. Community residents also indicated that the project has slowed erosion in the area. No quantifiable measurements were available to determine the effectiveness of this project.

**Figure 24. Geotube Containment Structure**

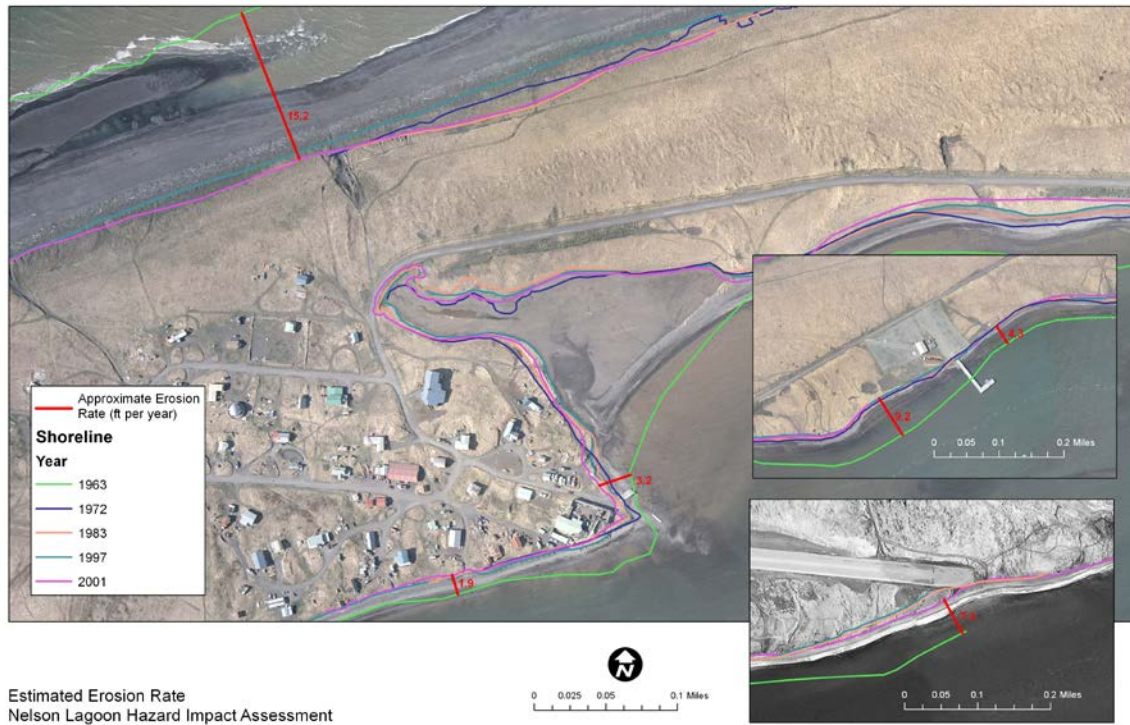
In Nelson Lagoon, the beach area historically tends to wash out in one area and then rebuild in another. The active erosion area along the Nelson Lagoon side of the spit is less than 100 feet from community structures, including housing and the runway. According to the USACE, major erosion events in the community have been constant for the last 20 years, resulting in an average of five feet per year of shoreline erosion (USACE 2007). Along the spit, erosion occurs at an approximate rate of one to two feet per year, per the USACE Erosion Information Paper; however, no specific measurements of extent were provided. In 2009, historical shoreline mapping was done by digitizing shorelines from the 1963 USGS quadrangle map and aerial photography from 1972, 1983, 1997, and 2001. Based on this historical shoreline mapping, erosion rates at various points along the shoreline were approximated. The results are shown in Figure 25.

Figure 25. Approximate Erosion Rates

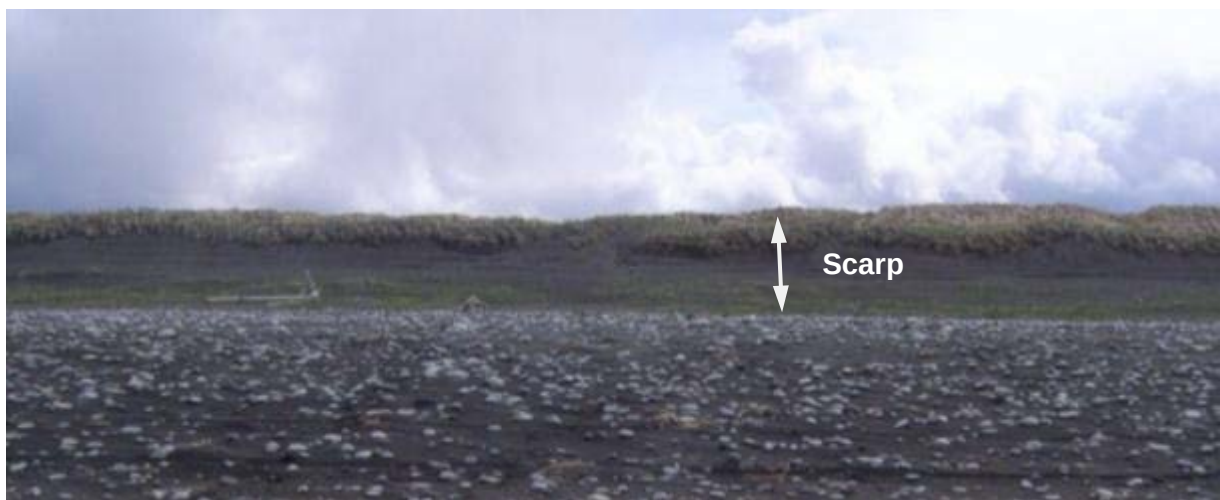
Cross-shore (onshore and offshore) transport of sand is an additional contributor to shoreline change. As discussed in Section 2.3.6.6, onshore and offshore transport are typically relatively balanced except during major storms. Evidence of erosion caused by cross-shore transport is shown in Figure 28, a photograph taken on May 23, 2011, along the Bering Sea shoreline of Nelson Lagoon. Along the back beach, note the approximate three- to five-foot-high scarp. This feature is probably sustained by large waves during high tides or storms. Cordova et al. (2010) and others have reported significant erosion of the seaside shoreline of Nelson Lagoon due to intense storms, often occurring during the fall. An 11-mile-long water transmission line runs from the mainland out to the community and has been damaged multiple times by erosion along the seaside shoreline (Figure 29). In at least one instance, a breach of the shoreline was reported but has since recovered (Cordova et al. 2010).

**Figure 28. Bering Sea Shoreline (Facing Landward)**

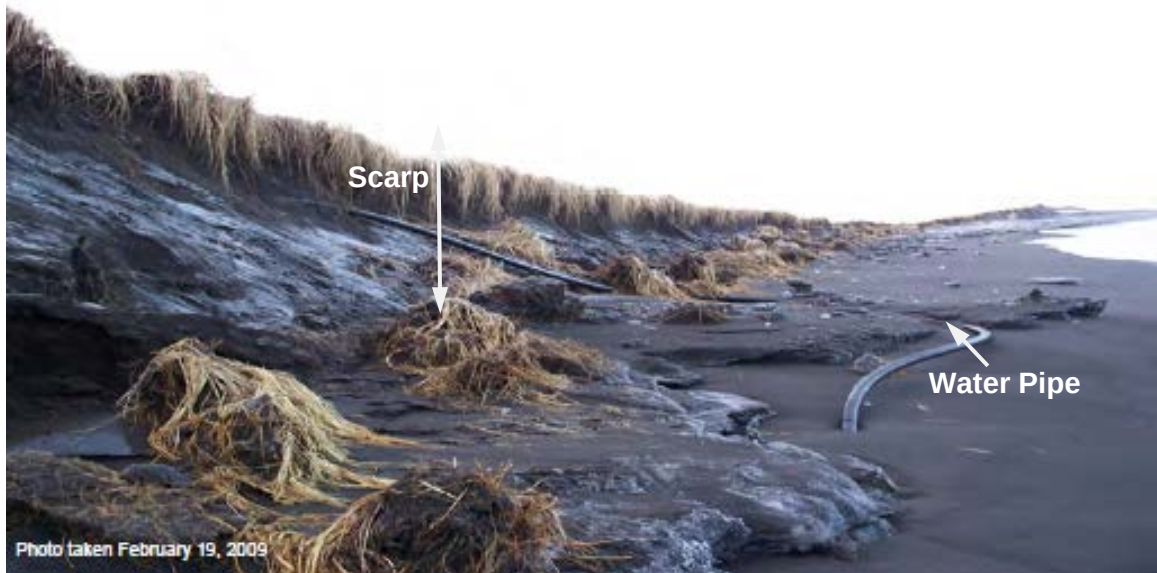
Figure 29. Bering Sea Shoreline Erosion (HDR 2010b; Notice exposed water transmission pipe)
