# Nelson Lagoon Hazard Impact Assessment

Aleutians East Borough  
3380 C Street, Suite 205  
Anchorage, AK 99503

HDR Alaska, Inc.  
with  
Shannon & Wilson

October 2011

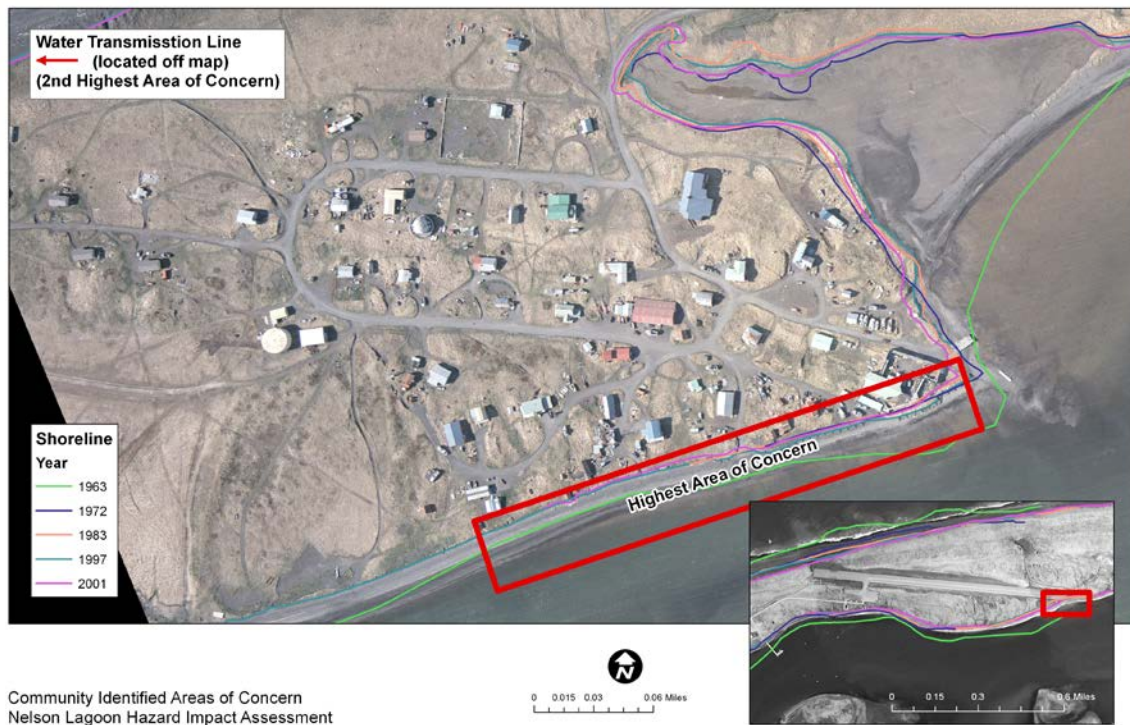
Figure 16. Community-Identified Areas of Concern

During the first site visit, Laurie Cummings with HDR Alaska and Eric Anderson with Shannon & Wilson met with members of the community. They talked about areas of Nelson Lagoon that have been impacted by hazards over time. The areas of concern to community residents are shown on Figure 16.

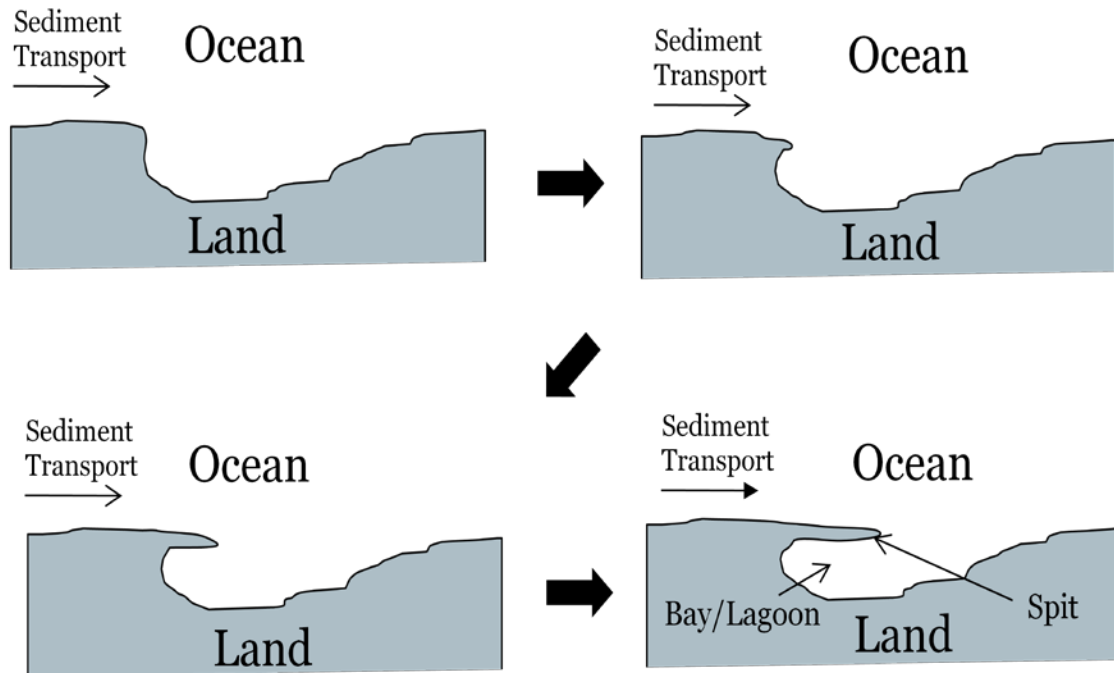
Figure 26. Schematic of Spit Forming over Time

formed over a long period time (decades to centuries) by prevailing longshore sediment transport. Figure 26 schematically illustrates spit formation.

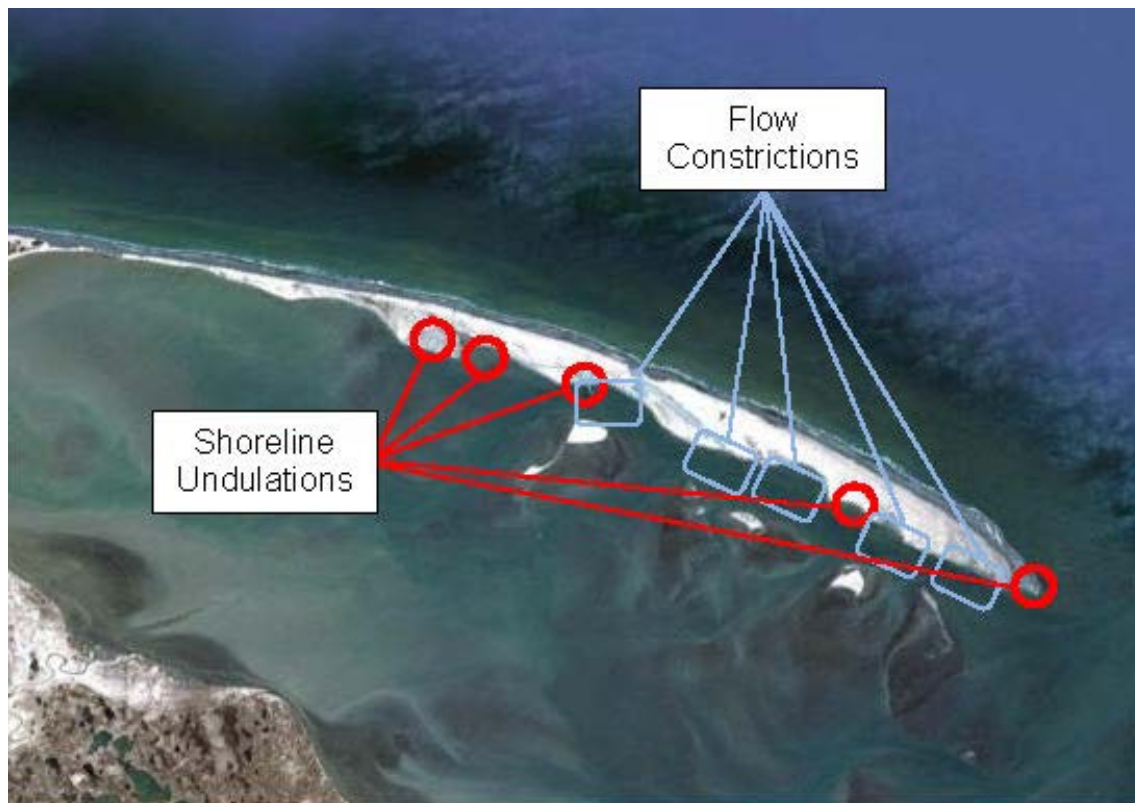
Figure 30. Potential Areas of Amplified Tidal Currents

In addition to waves, tidal currents were considered a mechanism for erosion along the bay shoreline of Nelson Lagoon. Various geometries of a bay, such as sharp undulations in the shoreline, abrupt changes in water depth, and focusing or narrowing of the water body, can constrict and/or amplify tidal currents. Figure 30 shows potential areas where this might occur in Nelson Lagoon. Changes in water depth were not evaluated due to lack of bathymetry for this area. More detailed hydrodynamic analysis within Nelson Lagoon would help identify areas of increased tidal current and potential erosion hotspots.
